Danish Watercourses

- Ten Years with the New Watercourse Act

Miljønyt nr. 11 1995

Collected Examples of Maintenance and Restoration

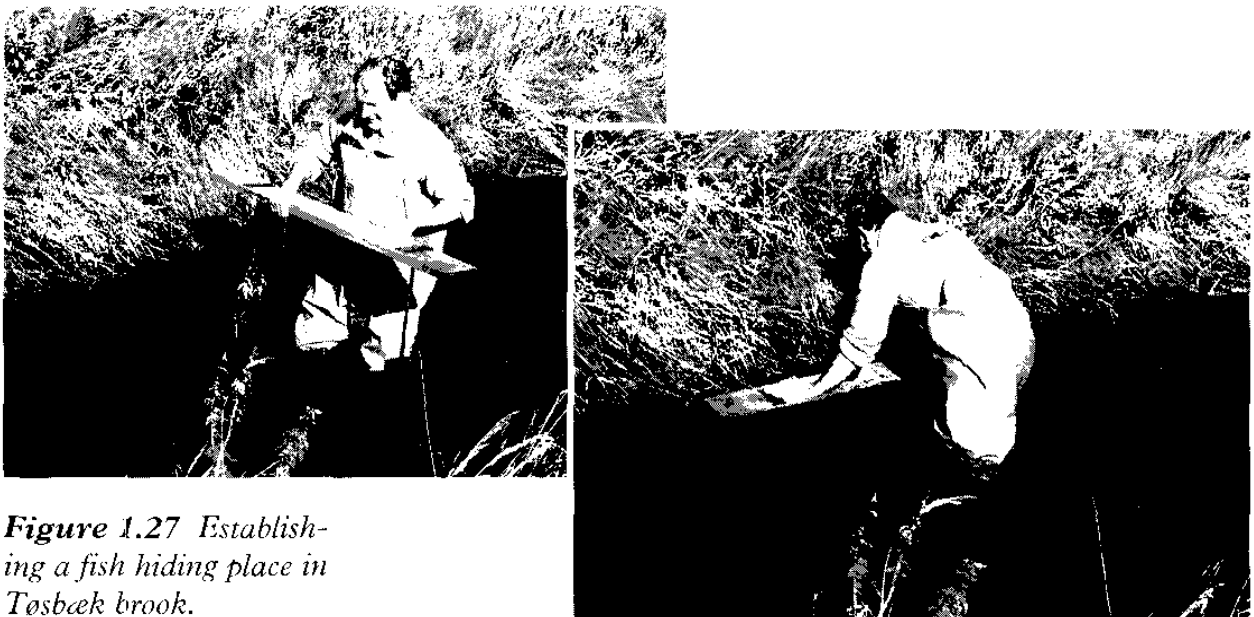
Figure 1.27 Establishing a fish hiding place in Tøsbæk brook.

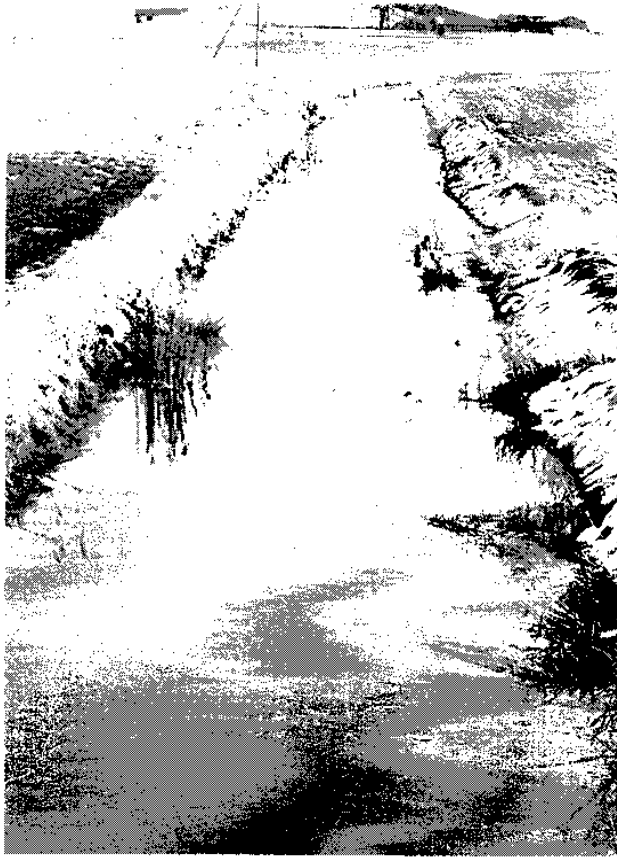
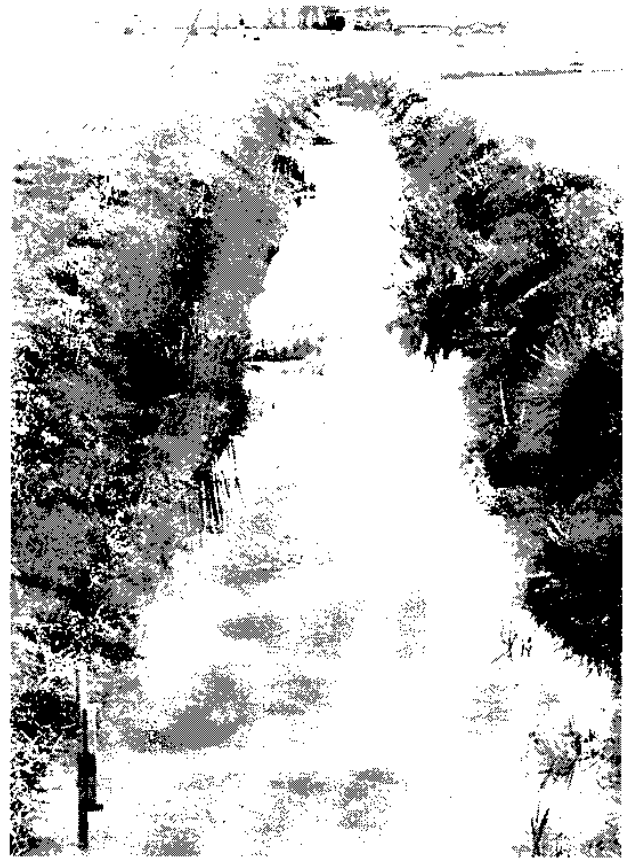
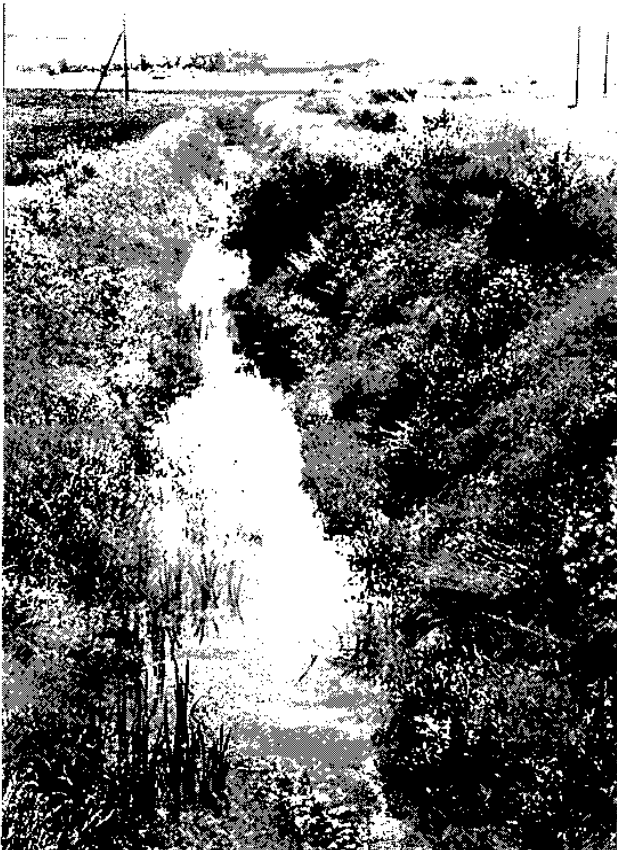
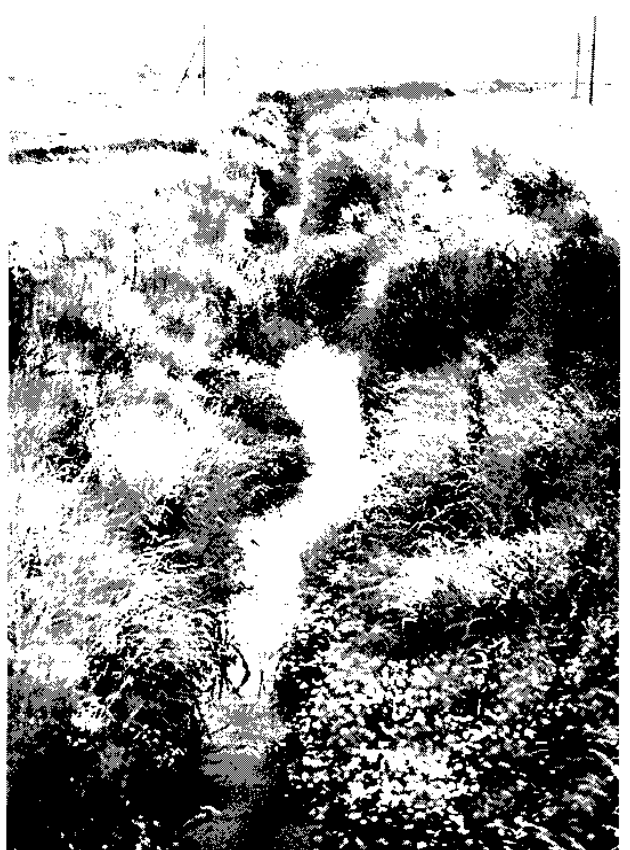
Figure 2.16 *Skivören stream in Thisted Municipality was transformed between 1987 (upper left) and 1990 (lower right) by switching to the current channel method of weed clearance. Photographs by Frank Eliasson.*

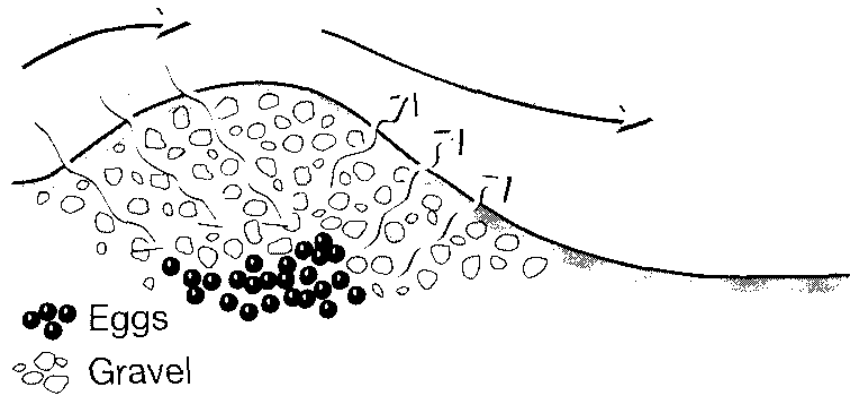
Figure 3.5 *The water should percolate freely through the nest.*

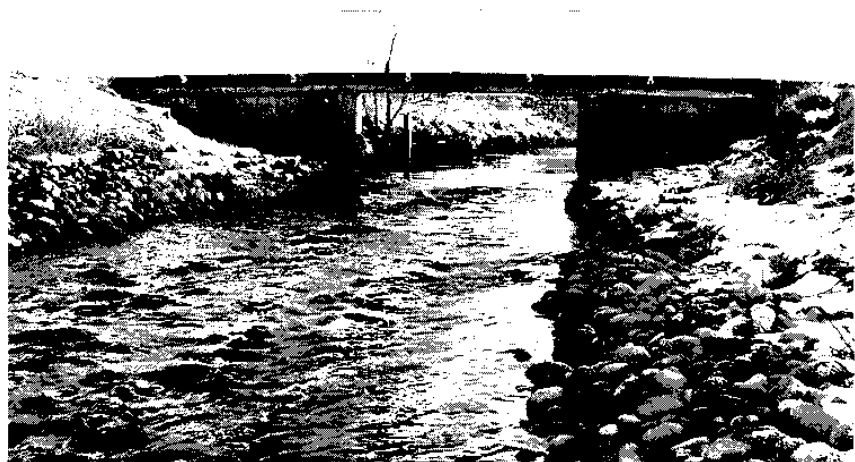
Figure 3.8 New spawning grounds in Tarm Møllebæk stream.

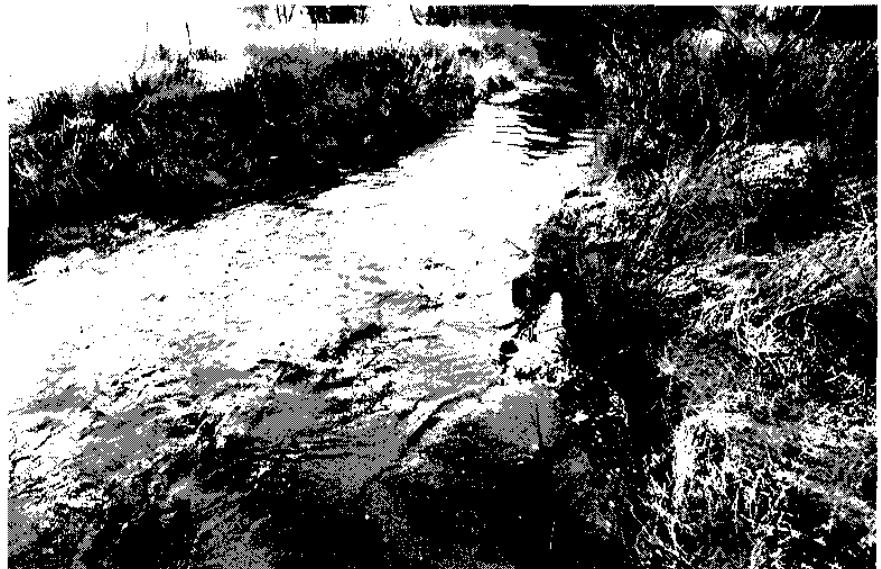
Figure 3.12 New spawning ground with turbulent water in the river Gudenå.

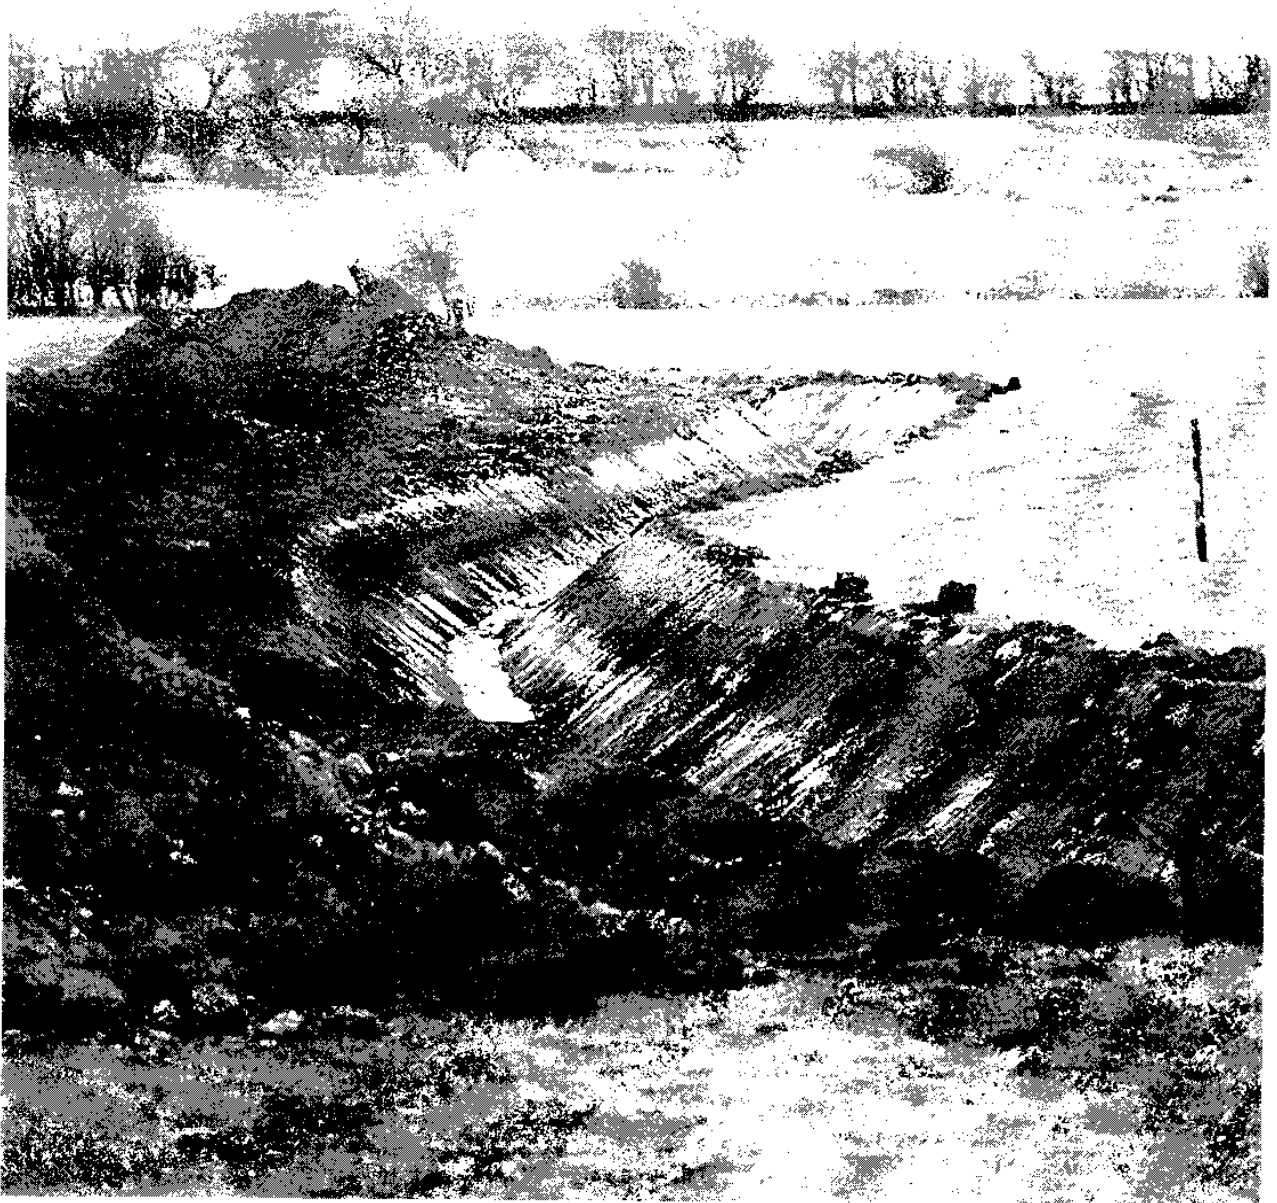
Figure 4.9 *A meandering brook was excavated alongside a culverted section of Isholm Landgröft brook. Photograph by Frank Eliasson.*

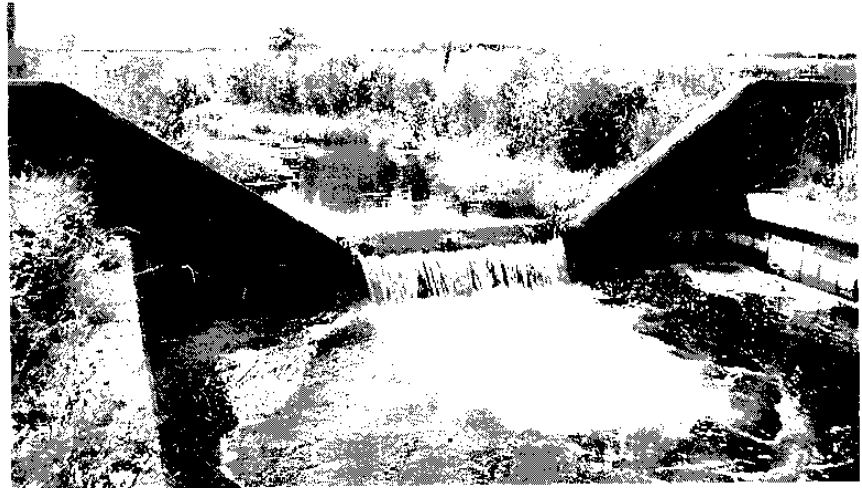
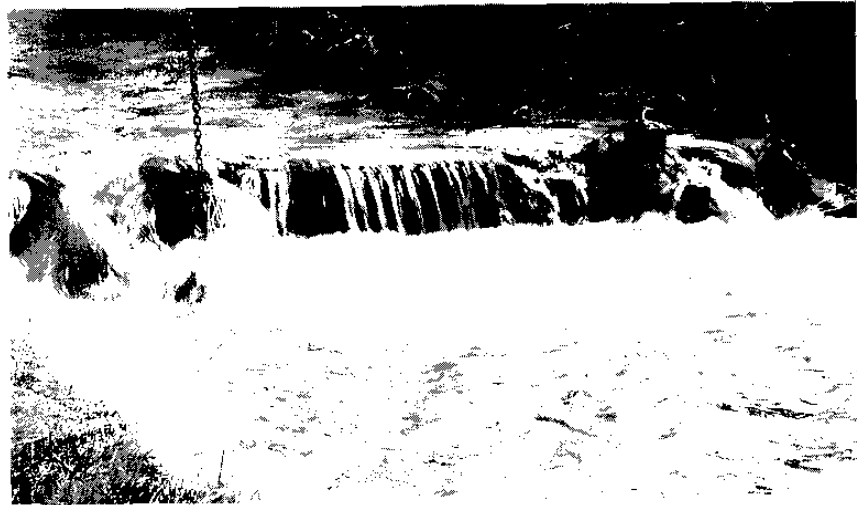
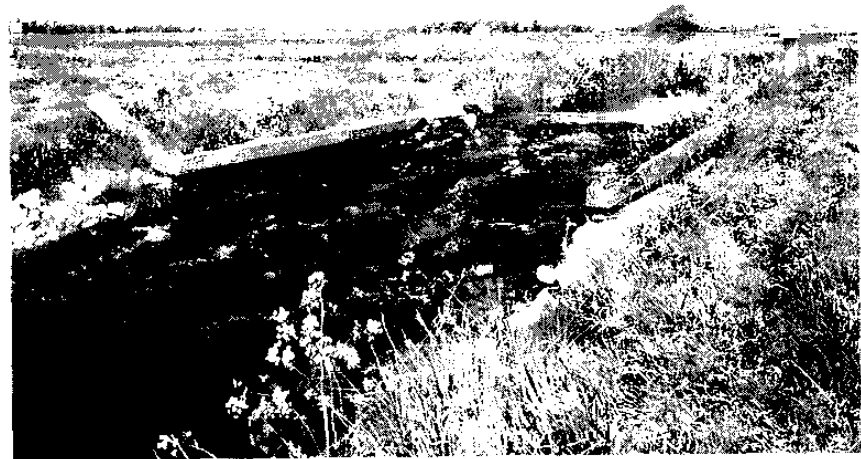
Figure 4.16 This is how weirs were modified in Sønderjylland in 1993; they were broken up and replaced by riffles.

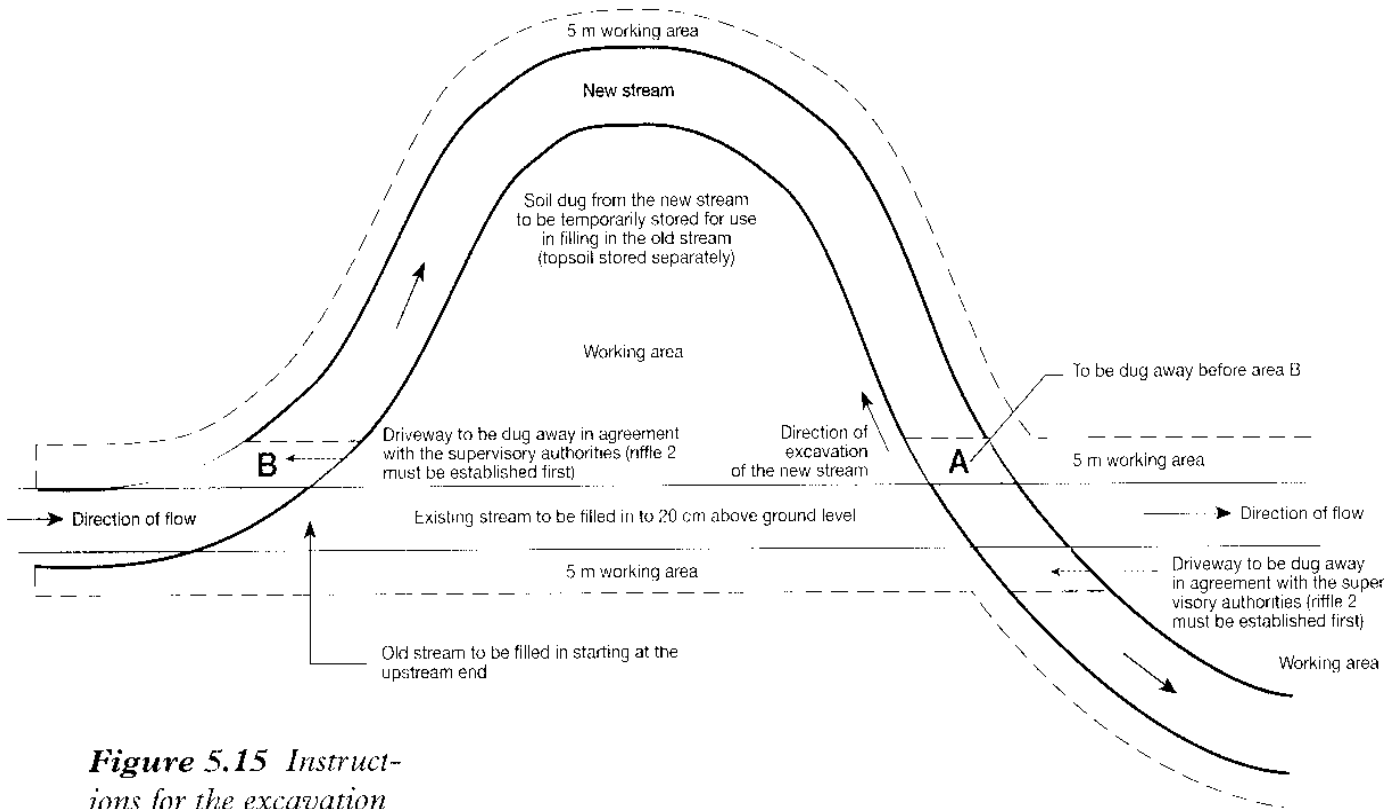
Figure 5.15 *Instructions for the excavation of new meanders in Gelså stream.*
