# 5th Semi-Annual Report on the Environment and the Øresund Fixed Link's Coast to Coast Installation

**5th SEMI-ANNUAL REPORT ON THE ENVIRONMENT AND THE ÖRESUND  
FIXED LINK'S COAST-TO-COAST INSTALLATION**

July-December 1997

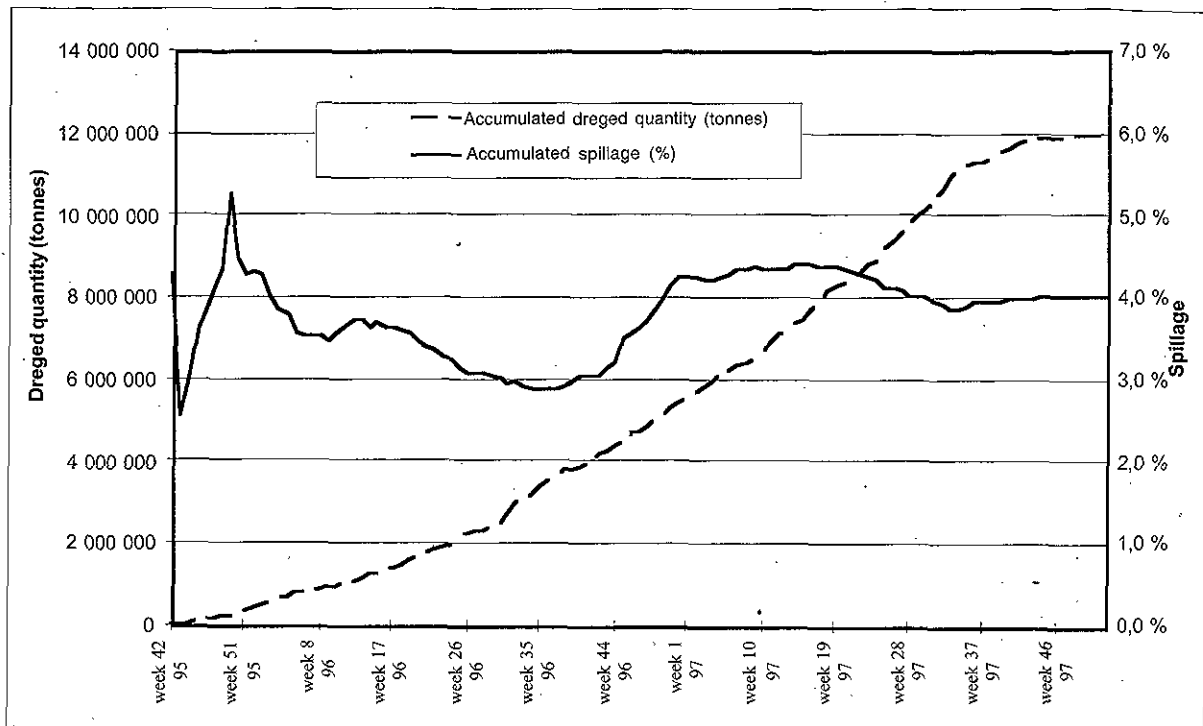
**Figure 2.** Development in time of the total quantity produced in tonnes and the accumulated spillage expressed as a percentage of the dredging work as a whole. Source: Öresundskonsortiet.

Development in time of the total quantity produced in tonnes, and the accumulated spillage expressed as a percentage of the total dredging work, is shown in figure 2. Figure 3 compares budgeted and actual spillage, and it will be seen that the actual spillage, especially during the latter half of 1997, has lain markedly below budgeted spillage.
